**FEDERAL MINE SAFETY AND HEALTH REVIEW COMMISSION**

SECRETARY OF LABOR,	:	CIVIL PENALTY PROCEEDING
MINE SAFETY AND HEALTH	:	
ADMINISTRATION, (MSHA),	:	Docket No. PENN 2009-12
Petitioner	:	A.C. No. 36-09491-162638
v.	:	
	:	
LITTLE BUCK COAL COMPANY,	:	Bottom Split Slope
Respondent	:

**DECISION**

#### Order No.7010827

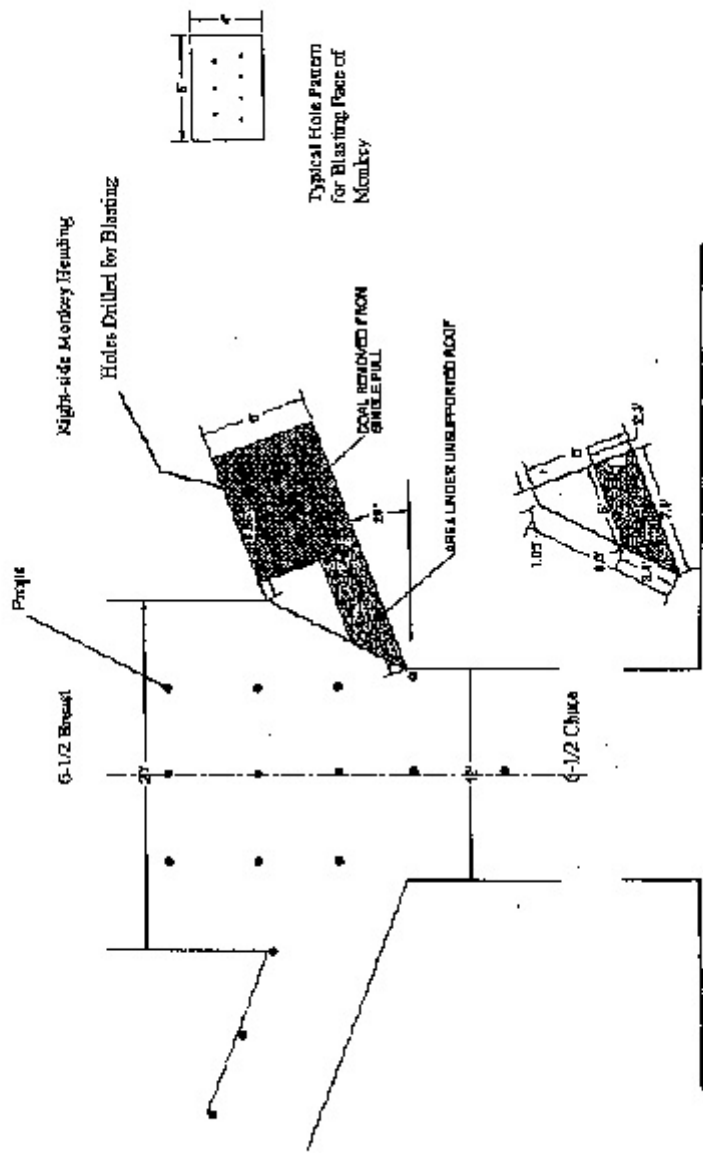
APPENDIX I PENN 2009-12  
 Government Exhibit G-3

About two weeks before the hearing, Mehalchick prepared a diagram of the area, using a computer program, "AutoCAD." Tr. 55-61; Ex. G-3. A copy of the diagram, an overview of the area of the six-1/2 chute and monkey heading, at a right angle to the coal seam, is attached as an appendix to this Decision. The diagram is not an exact depiction of the area, because the only dimensions used were the measurement on the low rib and Respondent's report of the length of the high rib and the width and height of the monkey heading. Mehalchick used the roof control plan's maximum allowable figures for the widths of the chute and breast, and assumed that the various elements were arranged symmetrically along a straight centerline. Tr. 54-60, 111. He also assumed that the transition from the 12-foot width of the chute to the 20-foot width of the breast occurred on "some kind of slant." Tr. 92-93, 111. When he entered the measurement from the low rib and the other dimensions into the computer program "everything tied in," that is, "all the dimensions fit," and the diagram was generated. Tr. 57-58, 111. The diagram also conformed with his recollection of his observations of the scene some two years earlier. Tr. 58, 111.

Mehalchick's and Garcia's concern was that Bender had worked under unsupported roof when he mined the second 7.5-foot cut in the heading. As shown on the diagram, the Secretary contends that the roof was not supported in a 2.3-foot wide trapezoidal area along the low-side rib, labeled "area under unsupported roof," and that Bender would have been in that area when he drilled and loaded the three holes closest to the low-side rib for the last cut. Ex. G-3.

Most significantly, the relative strength of the coal block, as compared to a single 5-inch diameter wooden prop, strongly suggests that the subject area should not have been considered unsupported. Mehalchick and Garcia agreed that the only action necessary to support the roof of the monkey, as they observed it, was the installation of one prop on the high-side rib within five feet of the breast.<sup>6</sup> Tr. 89-91, 156-58. Consistent with the approved roof control plan, that single prop would have rendered safe for travel the entire area of the monkey heading up to the 15-foot deep face, including the area in the diagram labeled "area under unsupported roof." Of course, at the time of the alleged violation, when the holes for the second cut were being drilled and prepared, there was no prop in that area. The last 7.5 feet of coal, shown as a cross-hatched area in the drawing and labeled "coal removed from single pull," was still in place, and the high-side rib was only one foot long.

In addition, the Secretary’s theory does not account for support provided by props that were installed in the chute and breast. While there was some disagreement on the location of props, the inspectors and Bender agreed that a prop had been installed close to the corner of the chute and the low rib, as depicted in the drawing. Tr. 59, 145, 174. The alleged unsupported area extends nearly to that prop. It appears, from the diagram, that other props are considered to have supported roof as much as five feet away, but that the prop on the lower corner of the trapezoid provided no support in the subject area. When questioned on that issue, Mehalchick stated that the prop provided support in the chute, but “nothing significant” in the monkey. Tr. 112. However, he later agreed that the prop “may” provide “a little” support in subject area. Tr. 122. Another concern is that, under the roof control plan, the 20-foot wide breast is supported by three rows of props at five-foot spacings, one down the center and one five feet from each rib. As depicted in the drawing, the row of props closest to the right rib of the breast was intact all the way down to the low-side rib of the monkey. It seems that those props may have provided adequate support in the breast up to the extension of the breast’s right rib line down to the low-side rib of the monkey. A dotted line has been added to the drawing showing the extension of the rib line. If so, the area considered unsupported would have been reduced by more than fifty percent, and would have extended only about two feet from the face where the subject holes were drilled. Bender may not have been that close to the face when he drilled and prepared the holes.

**BOTTOM SPLIT SLOPE MINE**  
 Overview - at Right Angle to Coal Seam
