FEDERAL MINE SAFETY AND HEALTH REVIEW COMMISSION

KNOX CREEK COAL CORPORATION,	:	CONTEST PROCEEDINGS
Contestant	:	
v.	:	Docket No. VA 2007-15-R
	:	Citation No. 7317341; 11/07/2006
SECRETARY OF LABOR,	:	
MINE SAFETY AND HEALTH	:	Docket No. VA 2007-16-R
ADMINISTRATION (MSHA),	:	Order No. 7317342; 11/07/2006
Respondent	:	
	:	Tiller No. 1
	:	Mine ID 44-06804
	:	
SECRETARY OF LABOR,	:	CIVIL PENALTY PROCEEDING
MINE SAFETY AND HEALTH	:	
ADMINISTRATION (MSHA),	:	Docket No. VA 2007-55
Petitioner	:	A.C. No. 44-06804-119560
v.	:	
	:	
KNOX CREEK COAL CORPORATION,	:	Tiller No. 1
Respondent	:	
	:	
SECRETARY OF LABOR,	:	CIVIL PENALTY PROCEEDING
MINE SAFETY AND HEALTH	:	
ADMINISTRATION (MSHA),	:	Docket No. VA 2008-215
Petitioner	:	A.C. No. 44-06804-141359A
v.	:	
	:	
ERNEST B. MATNEY, Employed by	:	Tiller No. 1
KNOX CREEK COAL CORP.,	:	
Respondent	:

DECISION

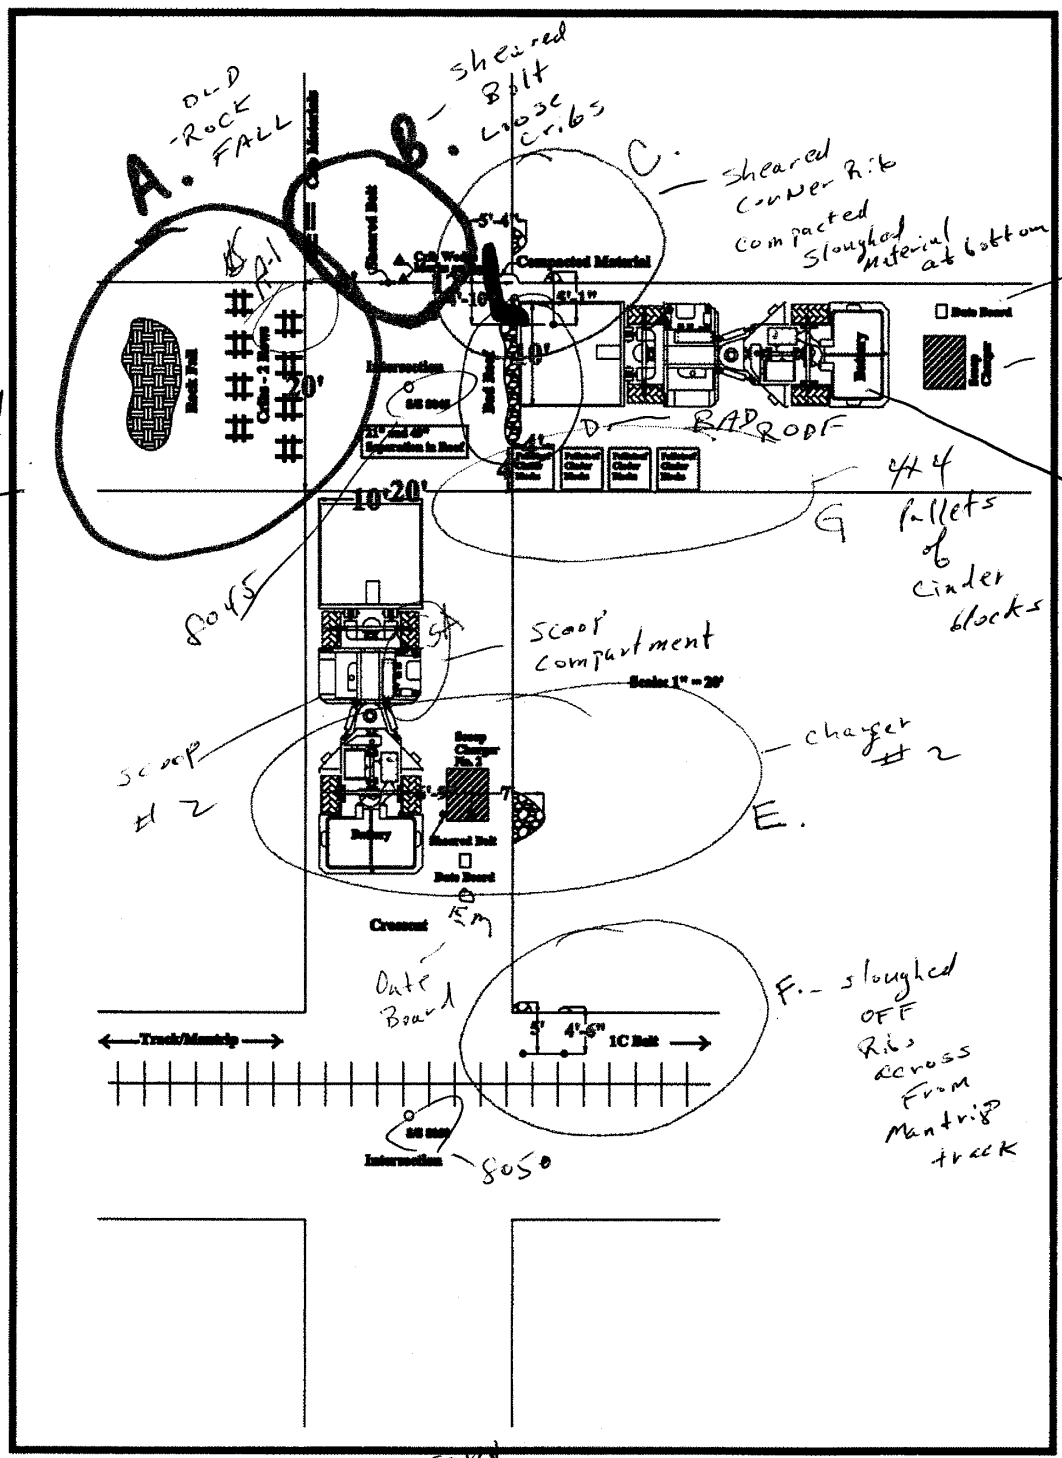
⁵ Government Exhibit 7 has been appended to this Decision as "Appendix I."

At the inby end of the intersection of the crosscut and No. 3 entry Phillips observed that the second roof bolt, located 8 feet from the left rib and 12 feet from the right rib, had been sheared off. (App. I, "Area B"). The severed bolt was covered with rock dust. The bearing plate and "pizza pan" used to support the draw rock were missing. Phillips testified that he observed marks that were brownish in color near the sheared bolt. (Tr. 119). Phillips believed the brown marks were beyond the area where the "pizza pan" would have been located. (Tr. 166). Phillips surmised the marks were made by a wooden wedge that was used to tighten a crib to the roof that had been installed as a substitute for the damaged roof bolt. Throughout these proceedings, Knox Creek has maintained that a crib had never been installed under this damaged roof bolt. (Tr. 293-96).

Phillips also noted approximately 30 loose crib blocks lying on the mine floor along the crosscut's left rib inby its intersection with the No. 3 entry. (App. I, "Area B"). The dimensions of a crib block are 6 inches in depth and 3 feet in width. (Tr. 120). The stacking of four crib blocks creates approximately one foot of crib height crib. (Tr. 121). Consequently, it would require approximately 24 crib blocks to construct a crib that was six feet high. Because of the brown roof marks he had observed, Phillips concluded that the loose crib blocks lying along the crosscut rib were the dismantled remains of a crib that had been installed to support the roof area surrounding the sheared bolt. (Tr. 122, 167).

Phillips observed the inby corner of the right rib of the crosscut in the intersection of the No. 3 entry had sloughed off causing the first row of roof bolts to be 61, 58, and 64 inches from the rib in violation of the approved roof control plan that required the distance from rib to bolts to be no more than 48 inches. (App. 1, "Area C"). Phillips also observed that the sloughed material had been compacted on the floor reflecting that the material had been run over by the No. 1 scoop as it turned the corner from the No. 3 entry into the crosscut. Since there were four by four pallets of cinder blocks on the floor adjacent to the outby rib in the No. 3 entry, Phillips concluded that the No. 1 scoop would have had to hug the inby rib as the scoop approached the battery charger. (App. 1, "Area D"). This would expose the operator compartment of the scoop, which is located on the right hand side, to the corner of the rib that was compromised. As noted, day shift foreman Stiltner testified that his crew did not remove the No. 1 scoop from its charger prior to Phillips' inspection. Consequently, as previously discussed, the damaged rib and compacted material on the mine floor apparently existed at the time of Matney's preshift examination that occurred before Stiltner's day shift operations. (Tr. 480-483).

Standing at the date board in the crosscut inby survey station 8050, Phillips observed a sheared roof bolt that was located over an outby corner of the No. 2 battery charger. The sheared bolt was four feet from the right rib. (App. 1, "Area E"). The charger receptacle was lying on the charger and had not yet been plugged into the No. 2 battery. Phillips was concerned that a miner would be exposed to the sheared bolt area when he attempted to attach the No. 2 battery to the scoop.

Phillips also observed sloughage of the right rib in the area that was adjacent to the No. 2 charger. He determined the distance from the sheared bolt to the deteriorated rib was seven feet, indicating that three feet had fallen off of the rib. Riordan and Stiltner testified that they never observed this deteriorated rib condition during their preshift and onshift examinations. (Tr. 232-34, 319).
