### FEDERAL MINE SAFETY AND HEALTH REVIEW COMMISSION

JIM WALTER RESOURCES, INC., Contestant	: CONTEST PROCEEDING
Contestant	: Docket No. SE 2006-295-R
V.	: Citation No. 7684534; 07/21/2006
	:
SECRETARY OF LABOR,	:
MINE SAFETY AND HEALTH	:
ADMINISTRATION (MSHA),	: No. 4 Mine
Respondent	: Mine ID 01-01247
SECRETARY OF LABOR,	: CIVIL PENALTY PROCEEDING
MINE SAFETY AND HEALTH	:
ADMINISTRATION (MSHA),	: Docket No. SE 2007-197
Petitioner	: A.C. No. 01-01247-110958
	:
V.	:
	:
JIM WALTER RESOURCES, INC.,	:
Respondent	: No. 4 Mine

#### **DECISION**

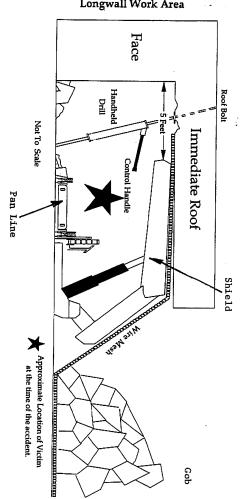
APPENDIX

three feet high that ran for 30 feet along the five-foot space between the tips of the shields and the face. Tr. 230, 341. The fall had been cleaned up, and a day shift roof-bolting crew, William Hardy, Garry Jones and William Ducker, began to install bolts where the previous shift had stopped. Hardy, who had over 28 years of mining experience at JWR, took the drill, Ducker was putting resin into the bolt holes and Jones, who had over 23 years of mining experience, was preparing bolts to be installed. The crew worked from the "pan line," the steel pan along which coal cut by the shear was transported to conveyor belts that removed it from the mine. The crew's work area under the longwall shields is depicted in a drawing in MSHA's accident report. Ex. G-4 at 8. A copy of the drawing is included as an Appendix to this Decision.

Longwall Work Area
